Smoke and Dye Testing Summary

High Level Sewershed

Run Summary

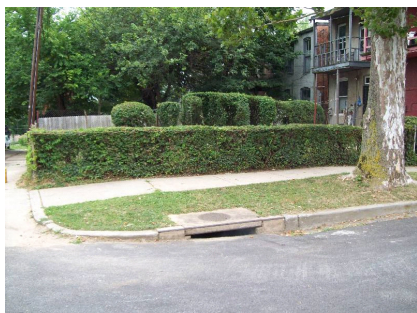
Picture \S1028-177-OB01-P01.jpg

Comments Smoke from catch basin along curb on Dukeland St. Near side yard of 2756 Mosher St.

Comments Side of house, 2756 Mosher St.
